ASHUELOT RIVER DAM

NH 00100
NHWRB 126.01

PHASE I INSPECTION REPORT
NATIONAL DAM INSPECTION PROGRAM

DECEMBER 1980

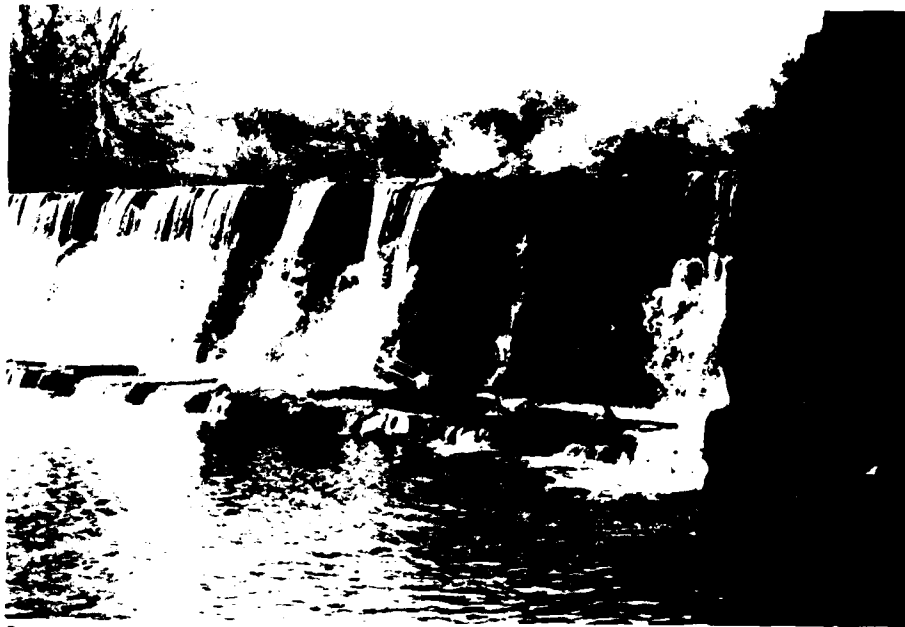
3. Downstream Left End of Spillway Showing Portion of Gate Structure at Left Abutment

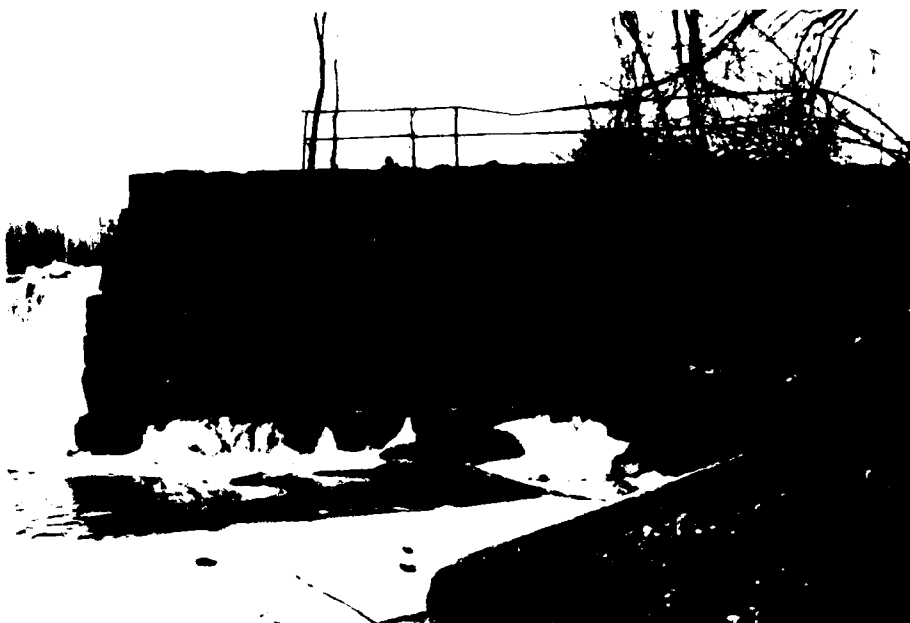
This structure consists of a cemented squared stone masonry forebay entrance which houses three foot sluice gates which are each approximately 5 feet by 6.5 feet. Vegetative growth is flourishing on the face of the wall. A triangular section of stone approximately one square foot in surface area has spalled from the face of the wall. Mortared joints have also spalled.

5. Gate Structure From Downstream Side - Note Concrete Slabs Placed on Bank for Slope Protection
